New Concept for Museum Storage Buildings – Evaluation of Building Performance Model for Simulation of Storage

New Concept for Museum Storage Buildings

Evaluation of Building Performance Model for Simulation of Storage

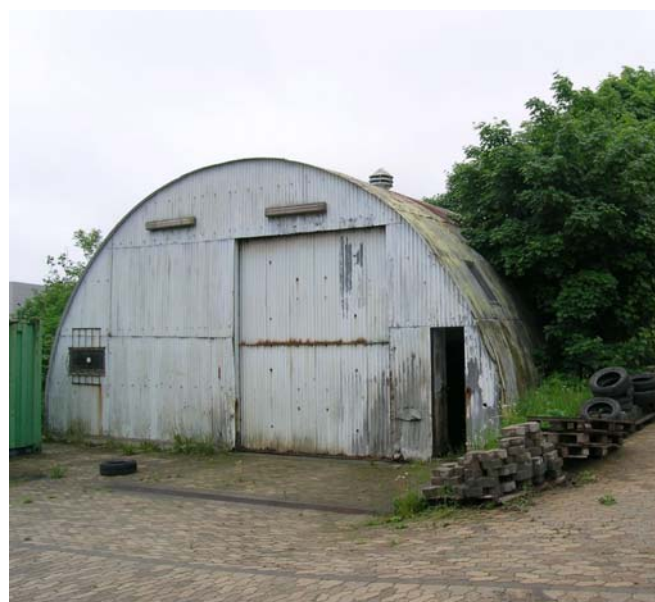
Figure 1. Museum storage building of inadequate quality.
(Photo: Camilla Bastholm).

The objects and art, which are not in exhibition, are kept in museums storage. Often the climates of the storage rooms are not ideal for keeping the chemical and physical decay of the objects as low as possible. The funding of museums is often limited and therefore most attention is given the exhibition, which is the visible part for visitors and donators. The expensive task of keeping good storage for the collections not on display is sometimes neglected or it is postponed to next year – every year, Fig.1.

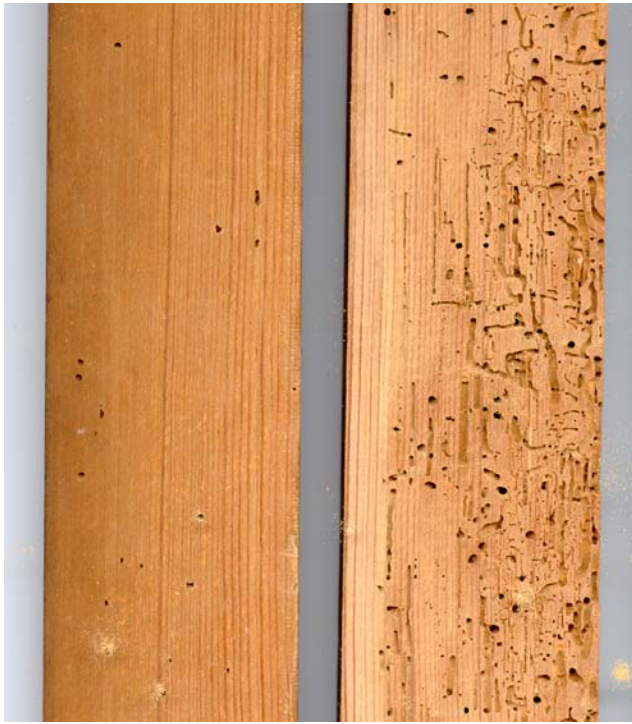
Figure 2. Left: Surface of a frame of a painting eaten by wordworms. Only a few holes in the frame is seen. Right: The same piece of frame after planning. Beneath the surface the frame is sizably damaged. Woodworms and other pests are common in humid storage facilities of museums.
(Photo: Lise Ræder Knudsen)

When objects of different materials are stored under inadequate conditions for years, many different damages occur. There can be attacks by pests. Woodworms eat wooden objects, Fig. 2. Moth, larder- and carpet beetle eat textiles, leather and fur; mold is growing on the objects of all materials, Fig. 3 and major structural damage of the objects will occur due to high or too low relative humidity, Fig. 4. Furthermore, mold-infected objects can provoke allergic reactions among the museum staffs. It is thus important to store objects under controlled and stable conditions.

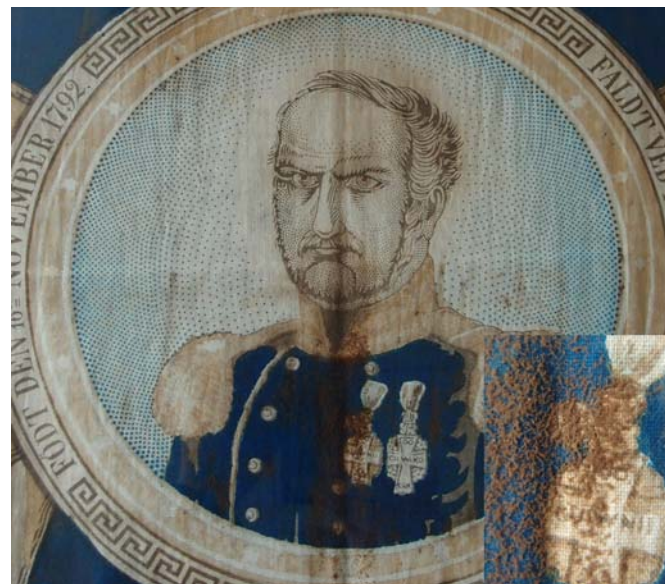
Figure 3. A textile mounted in a frame showing general Rye who died in battle 1849. Due to too humid conditions brown mold is growing especially on the chest and on one of the medals (Photo: Lise Ræder Knudsen).

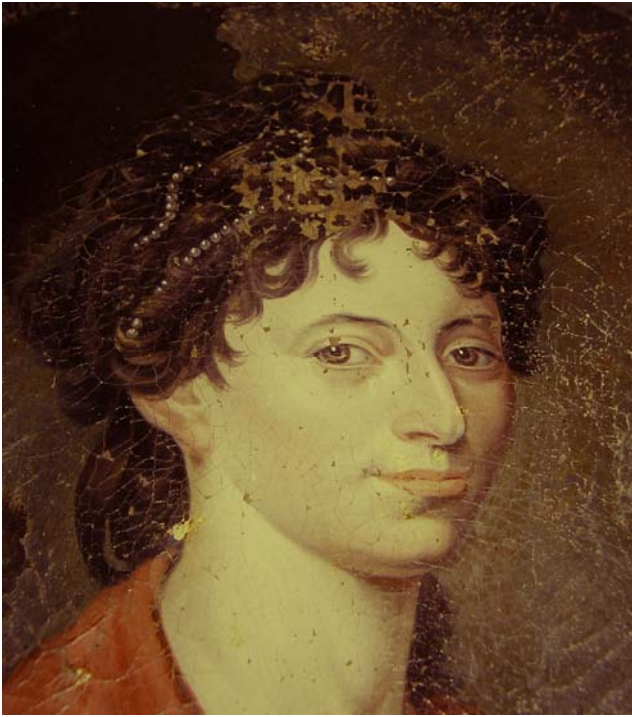
Figure 4. Portrait of Danish Queen Marie of Hessen-Kassel. The paint layers are seriously damaged due to very humid conditions. Small flakes of paint are missing especially in the hair. The paint layers and the canvas of the paint react differently on changes in the relative humidity.. (Photo: Anette Aalling)

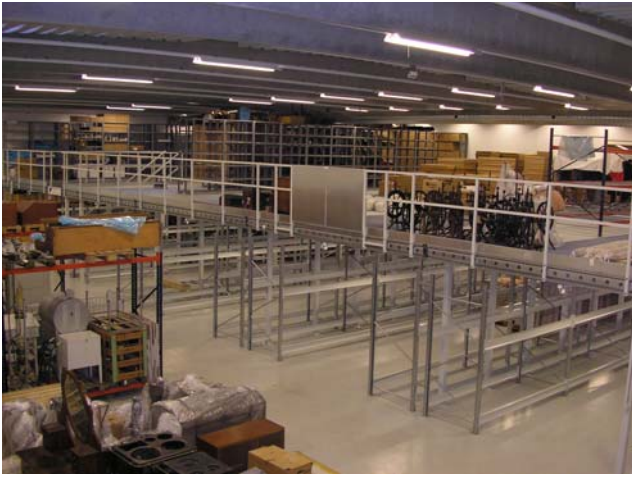
Figure 6. Picture of the interior of the museum storage showing the mezzanine construction (Photo Centre for Preservation of Cultural Heritage).

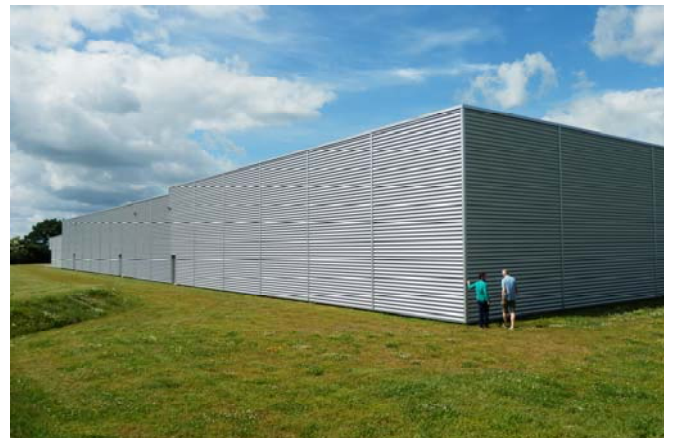
Figure 8. Exterior view on the storage building after completion. Old to the left and New to the right (Photo Christensen).

thickness of the roof and not the floor construction. In Fig. 8 the exterior view on the old and new storage building are shown after completion.
